# Building Report

123 Sample St Sampleville

# VISUAL BUILDING INSPECTION REPORT

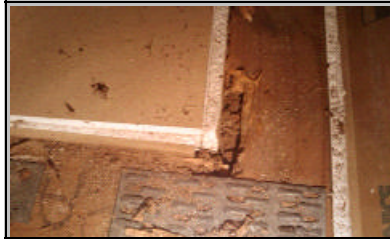
There appears to be moderate damage consistent with timber pest attack to visible accessible timbers. We strongly recommend an inspection by a qualified pest inspector be commissioned. Due to timber pest damage some timber replacement is required. The full extent of timber replacement and/or repair can not necessarily be determined during this visual inspection and a more invasive inspection will be required.

**Affected roof timbers**

Top wall plate timbers: Rafters:

A licensed builder should be called to make a further evaluation and repairs or rectification as needed. A licensed pest inspector should be called to make a further evaluation and recommendations as needed.

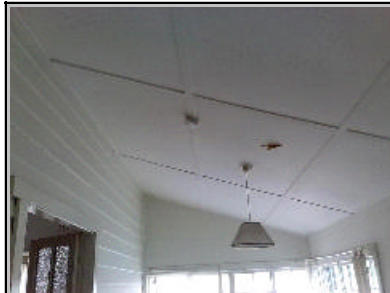
The condition of the ceilings is generally fair. Minor settlement cracks were noted and these are typical of this type of material. Periodic maintenance may be required. Minor cracking is present to cornices. This will require maintenance. Painting is of a poor standard and requires rectification. Peeling paint was noted to ceilings. Repairs are required to ceiling linings.

A Licensed painter should be called to make a further evaluation and repairs or rectification as needed. A plasterer should be called to make a further evaluation and repairs or rectification as needed.

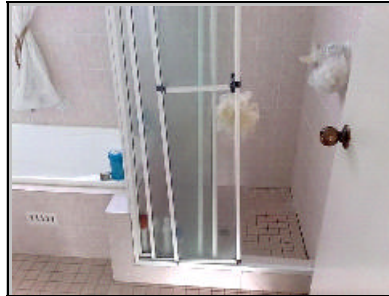
The shower recess was tested and there was no visible water penetration to surrounding areas. **IMPORTANT NOTE:** This test may not reveal water leaks until the shower is put into constant use and surrounding areas monitored over a period of time. Corrosion/Damage noted at the tap area. Shower screen doors require adjustment, maintenance or repair to operate smoothly.

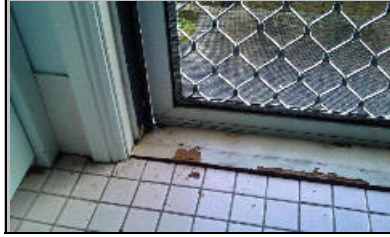
This area is generally in fair condition. External timber door seal has wood rot. Its essential a licensed carpenter replaces it as it could attract timber pests.

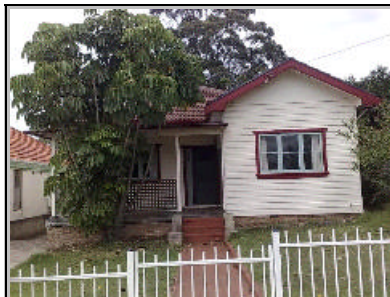
The condition of the walls is generally poor. The external wall timbers show signs of age and weathering. Maintenance and/or repairs will be required. Paint deterioration was present to external surfaces. Maintenance and/or repairs will be required. Severe wet rot decay is present to external walls. Recommend decayed timbers be replaced.

A licensed carpenter should be called to make a further evaluation and repairs or rectification as needed. A Licensed painter should be called to make a further evaluation and repairs or rectification as needed. A licensed pest inspector should be called to make a further evaluation and recommendations as needed.

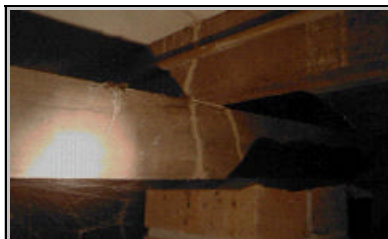
There appears to be moderate damage consistent with timber pest attack to visible accessible timbers. Please refer to pest inspection for details.

**Affected subfloor timbers**

A licensed pest inspector should be called to make a further evaluation and recommendations as needed.

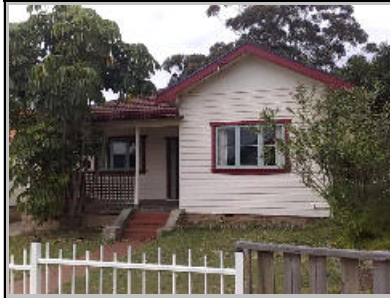
Cracks are evident. Visible cracking has been categorized as a structural defect. Cracking of a building element is a structural defect where in the opinion of the inspector the structural performance of the building element is impaired, or where the cracking is the result of the structural behavior of the building. The expected consequence of this cracking is unknown until further information is obtained.

This must be referred to a Structural Engineer to investigate.

We recommend an engineer be engaged to comment upon and offer further advise regarding the above issue.

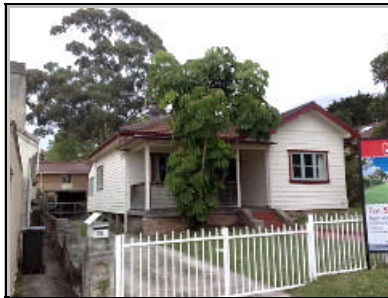
Trees are located close to the building with tree limbs over the roof area. Consideration should be given to the cutting back of tree limbs over roof areas by a professional contractor.
