Pest Report

123 Sample St Sampleville.

VISUAL TIMBER PEST INSPECTION REPORT

COMMISSIONED BY: Sample Report Lawyers.
YOUR CONTACT: Bob Smith.
YOUR REF/FILE NUMBER: 0001000.
DATE OF INSPECTION: 24th September 2010.
PURCHASER: John Cool.
VENDOR: Jill Blog.
PROPERTY ADDRESS: 123 Sample St Sampleville.
INSPECTED BY: John Lagakis.

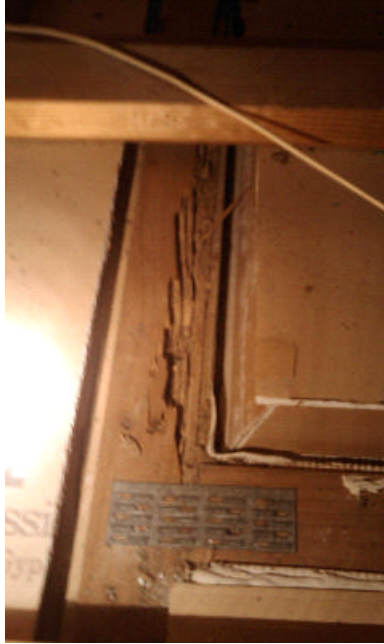
Yes - Inspection revealed currently inactive termite attack (damaged timbers and/or termite workings) within this area including but not necessarily limited to the following timbers and the areas listed below.

Top wall plate timbers:

Laundry:

Visible timber damage appears moderate however, we are not builders and this is not to be considered a builder's opinion. Refer to the definitions section of this report - Section 1.6 - Timber Damage.

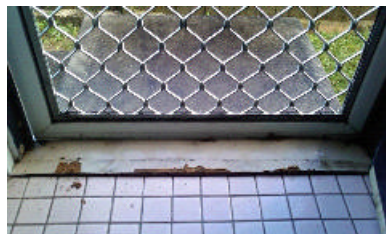
Yes - Wood decay damage was noted to the following timbers/areas.

Kitchen cupboard timbers: External door bottom seal.

Visible timber damage appears severe however, we are not builders and this is not to be considered a builder's opinion. Refer to the definitions section of this report - Section 1.6 - Timber Damage.

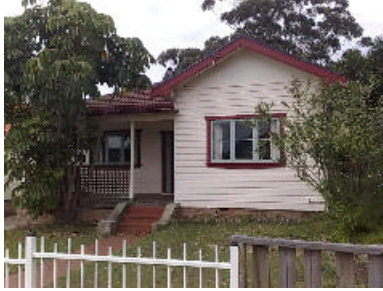
Yes - Wood decay damage was noted to the following timbers/areas.

Fascia timbers: Decking timbers:

Front section of the property:

Visible timber damage appears moderate however, we are not builders and this is not to be considered a builder's opinion. Refer to the definitions section of this report - Section 1.6 - Timber Damage.

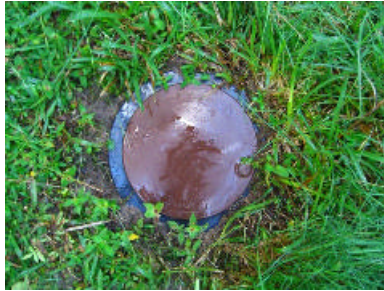
of a termite treatment program. We found evidence of a termite baiting system present at the property.

We found evidence that a termite treatment may have been carried out to this property. Where any evidence of a termite treatment or termite management system was noted, we strongly recommend any prospective purchaser research the documentation available in relation to this property and seek further information from the vendor in relation to any previous termite attack. The following evidence was found during our inspection. Evidence of trenching to the soil was noted. Trenching of soil is common as part
